Another Awesome Photo of Our Subdivision

PROJECT:
Crystal Dam
Feasibility Study

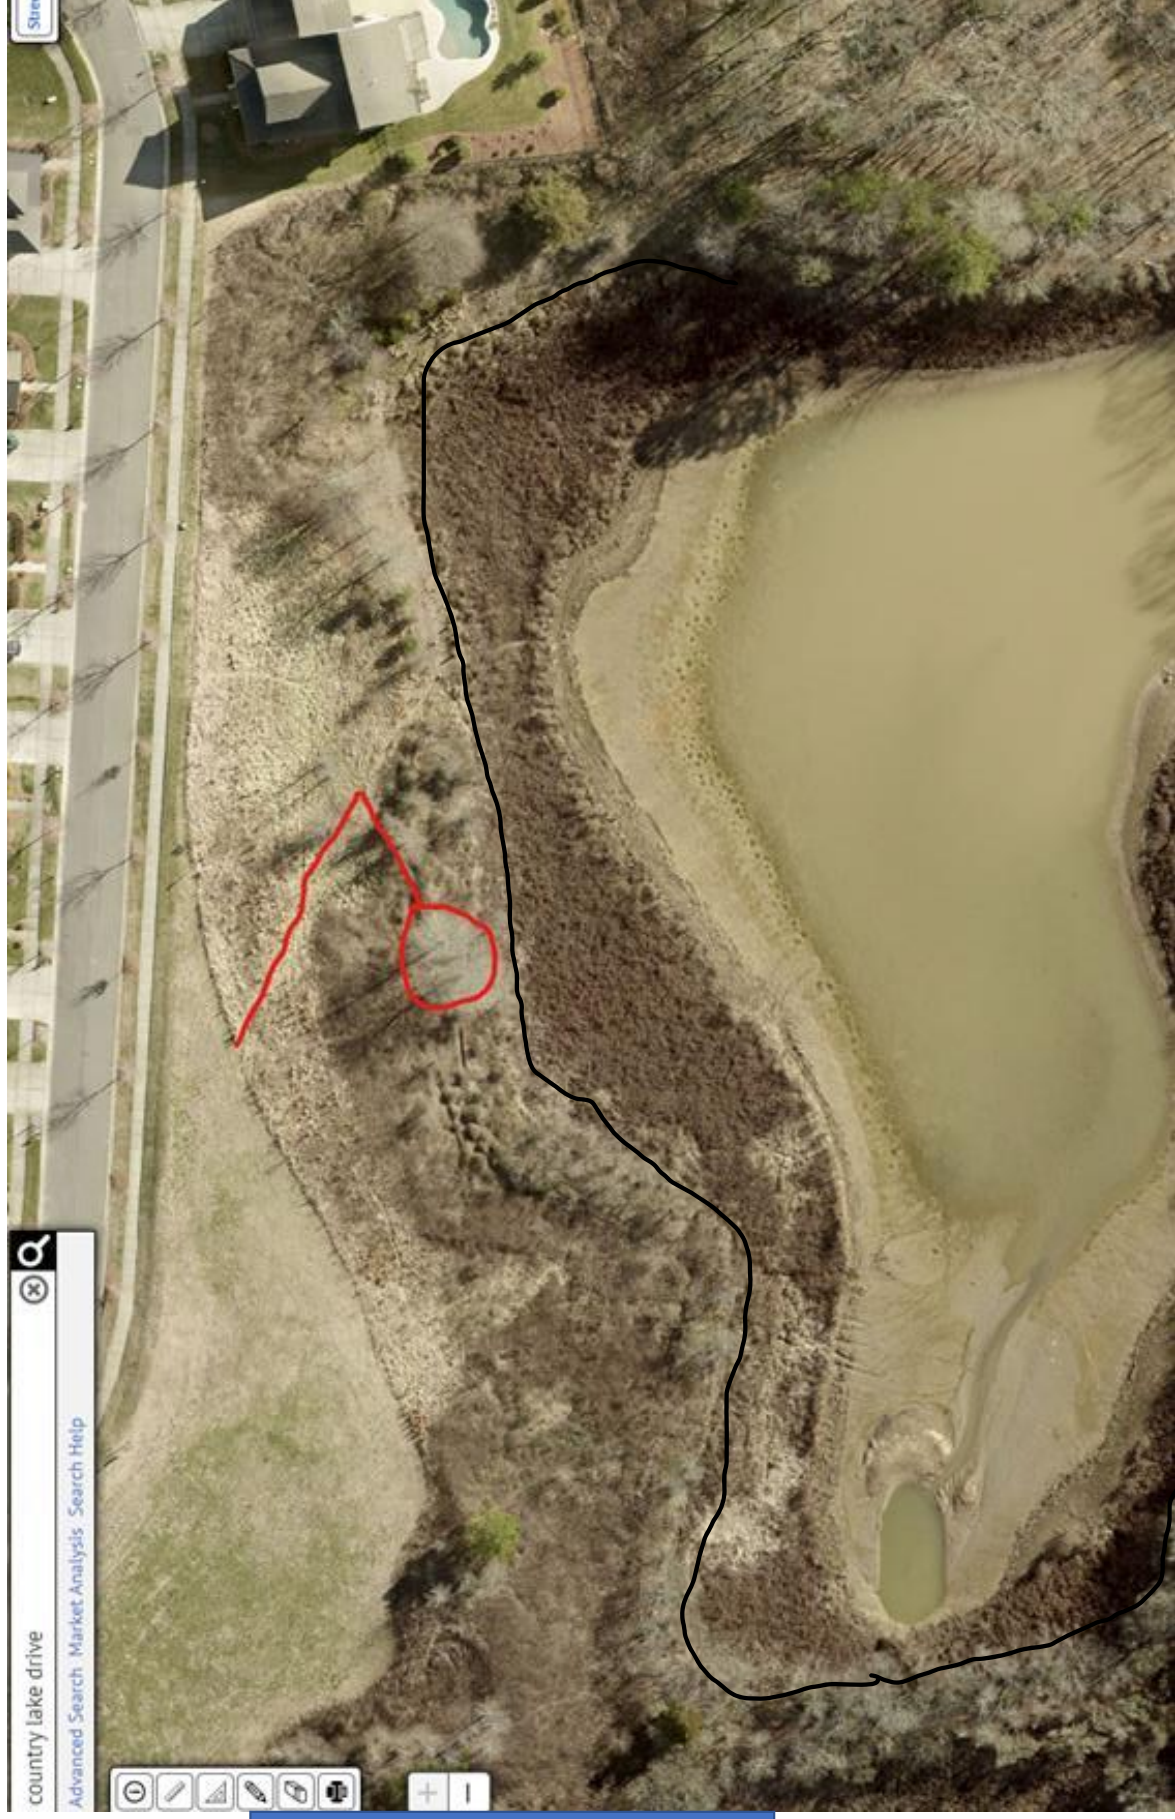
Red line-
Potential
walking path to
a scenic
overlook from
CLD. Note:
Steep side hill.

Black line is
water line when
restored.

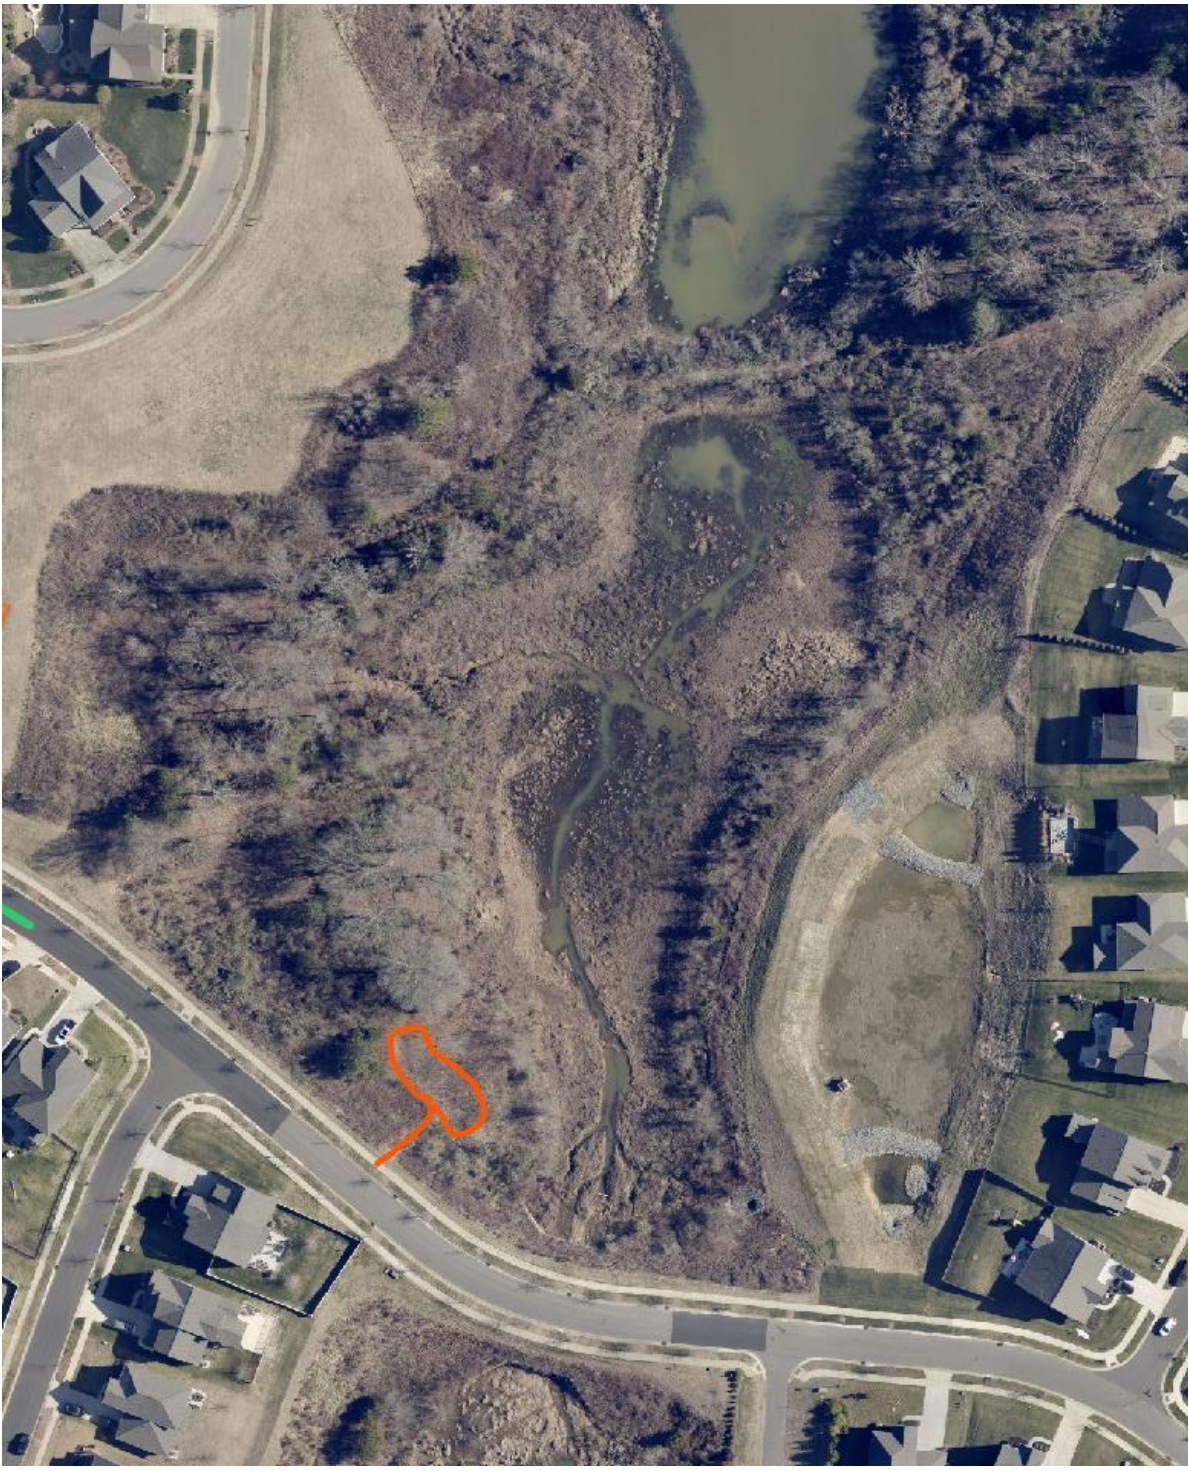
Path to a small clearing.
Scenic overlook , just North
of McCullough club Dr
Bridge..

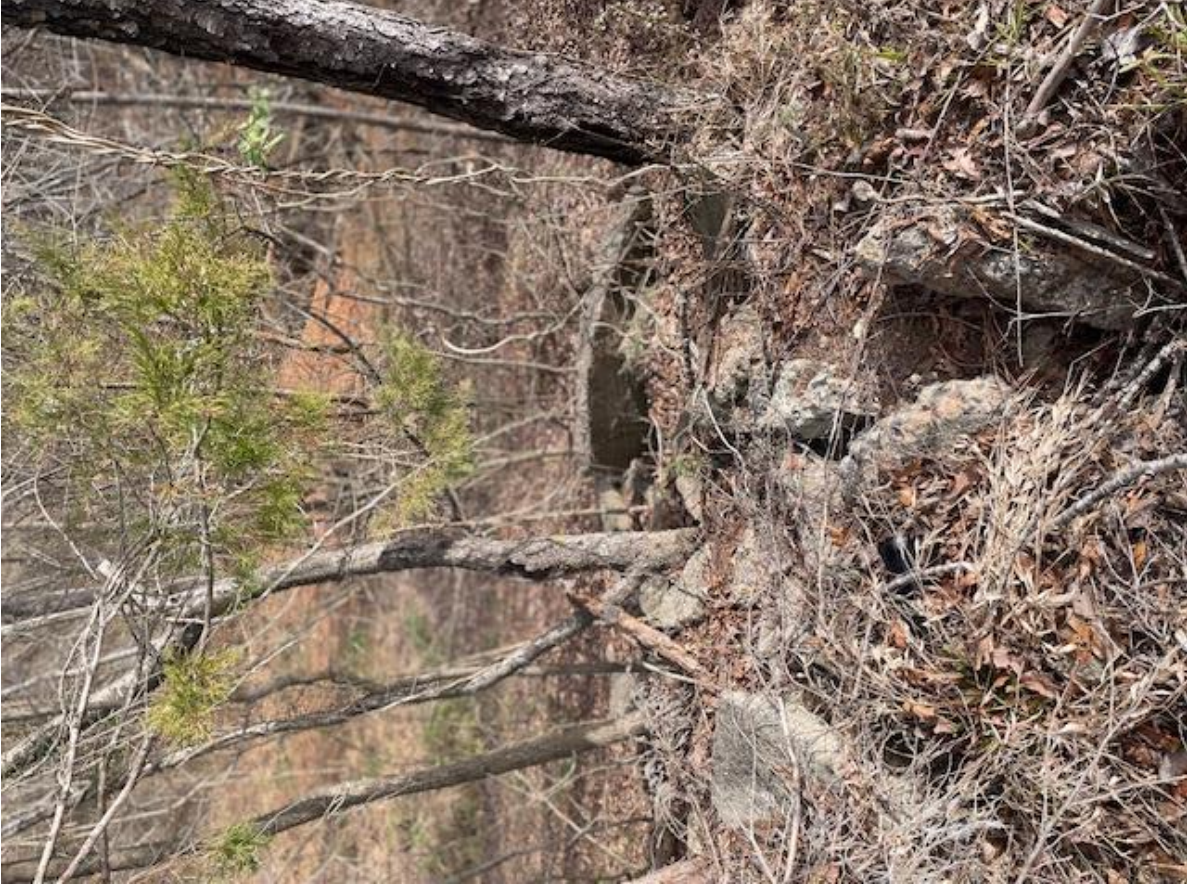
Secondary "Emergency
Overflow" Concrete
broken and washed out.

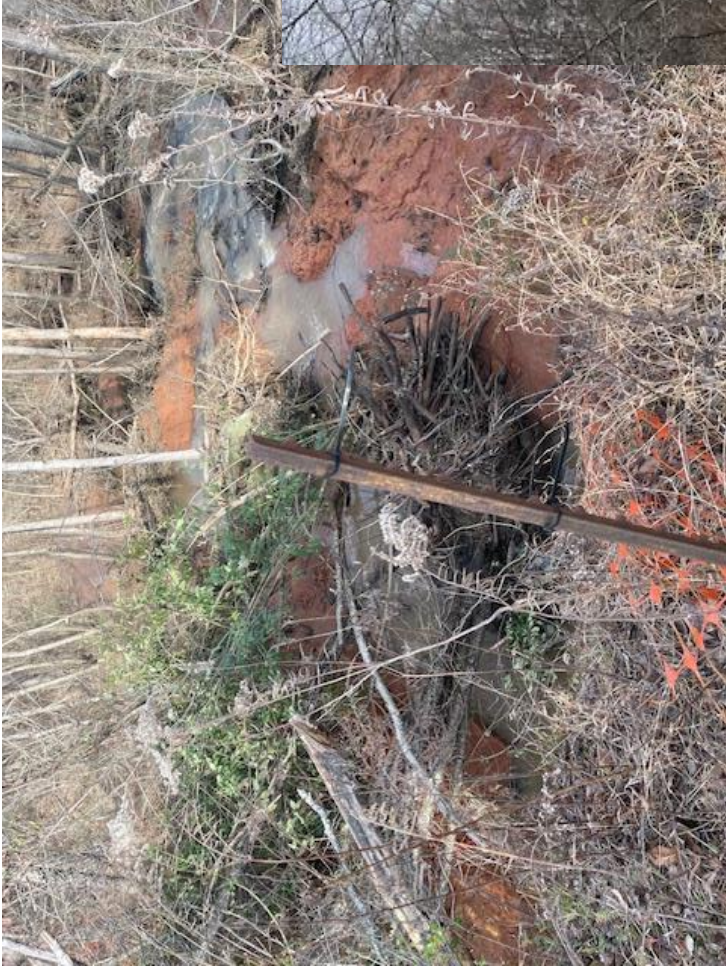
Additional erosion of the Dam and
breach following Spring 2024
Rainstorms

2nd install of Safety Fencing both sides
of Main Breach.

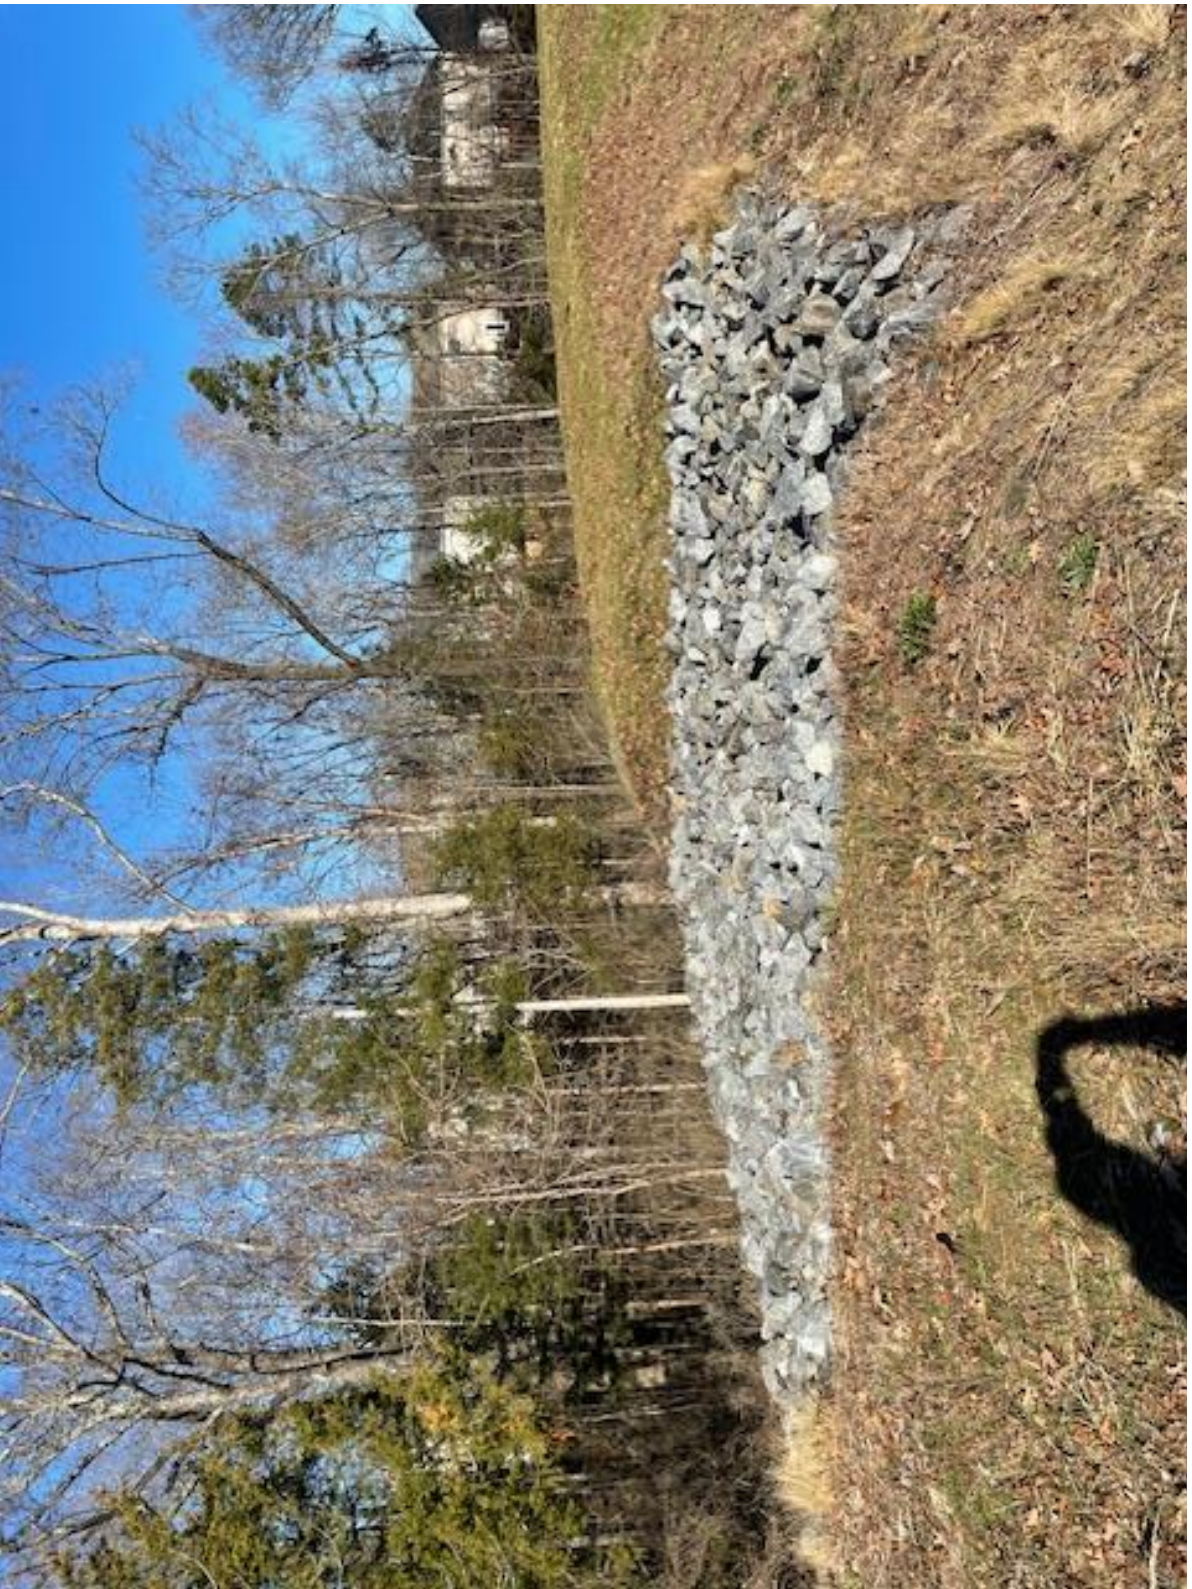
Typical Rip-Rap for Emergency spillway. One on each Dry Detention pond. Same proposed for Dam project.
